### **TEST REPORT**

Fire resistance test of an external wall when exposed to 80kW/m<sup>2</sup> of radiant heat in accordance with AS5113: 2016

44388000.1

QT Systems 423 Bradman Street Acacia Ridge, QLD, 4110

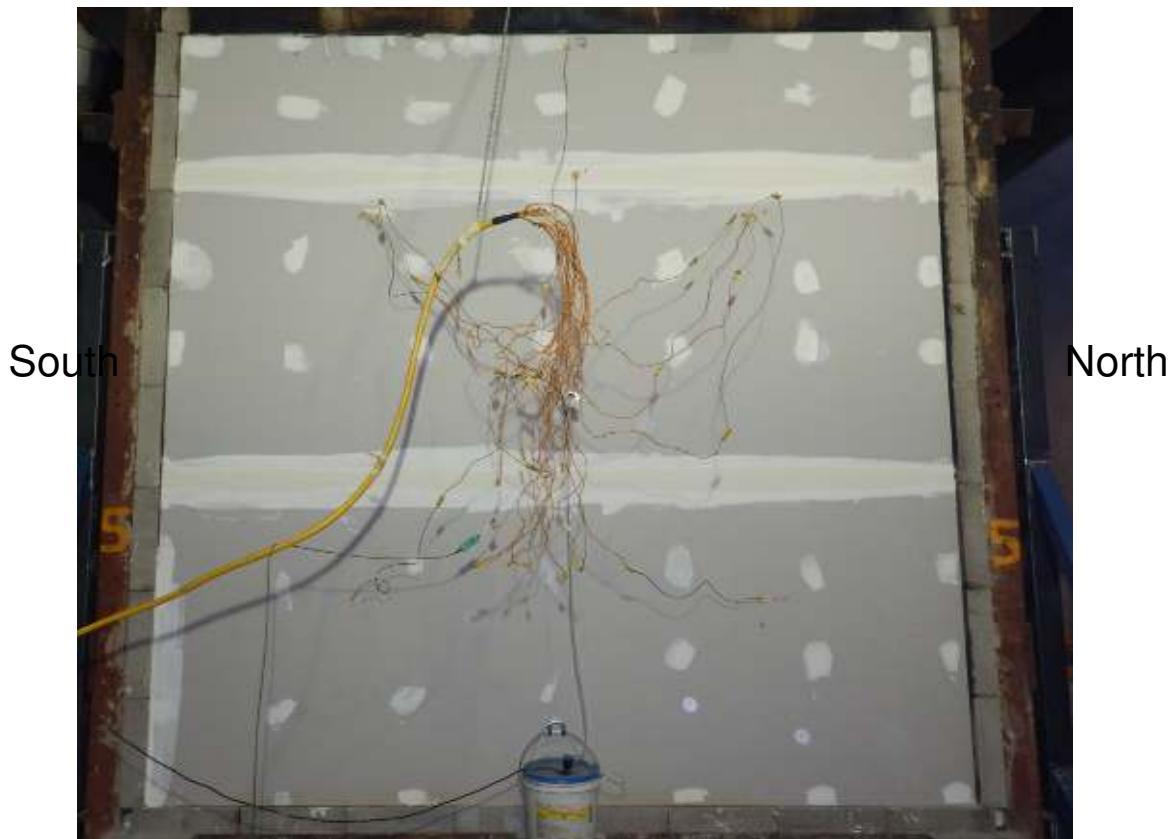
Figure A5.3: Unexposed face of specimen at the end of the test.

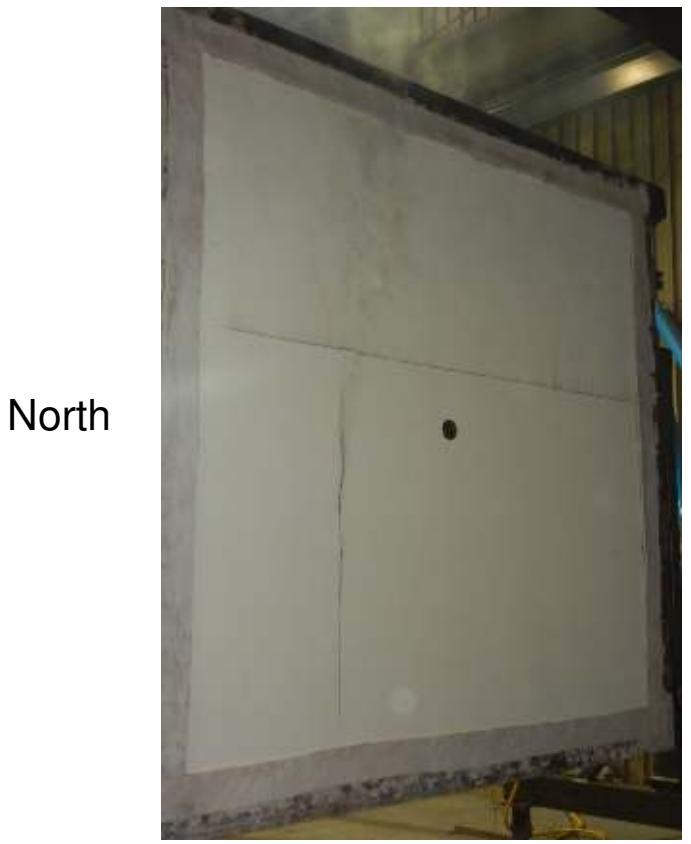
Figure A5.4: Exposed face of specimen at the end of the test.
