Australian Standard 5113
Fire Propagation Testing and
classification of external walls of
buildings

QT Panel with 10mm Cement
Render

PRODUCT EVALUATION
AND TESTING

IGNL-3282-08 I01 R01

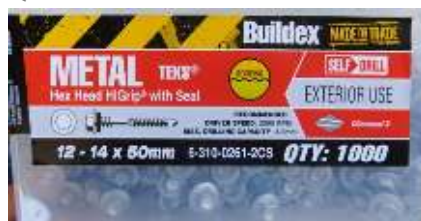
FIGURE 1:

- 2 x 13mm Fire rated plasterboard | CSR Fyrecheck (fixed to test wall sub-frame)
- Steel Top hats 20x25x50x25x20 1.15BMT fixed to stud frame through the fire grade plasterboard at 450mm spacings.
- 50mm QT panel horizontally installed with QT Buttons and fixed with 12-14 x 50mm Metal hex screws.
- The vertical joint as well as the horizontal joint located at 2.4m above the combustion chamber were installed as control joints with a 10mm gap. Polyurethane backing rod was installed and the gap sealed with Bostic FireBan One to a depth of 10mm.
- 10mm concrete render was installed over the completed QT Conpolcrete wall system

QT SYSTEM FIXING SYSTEM

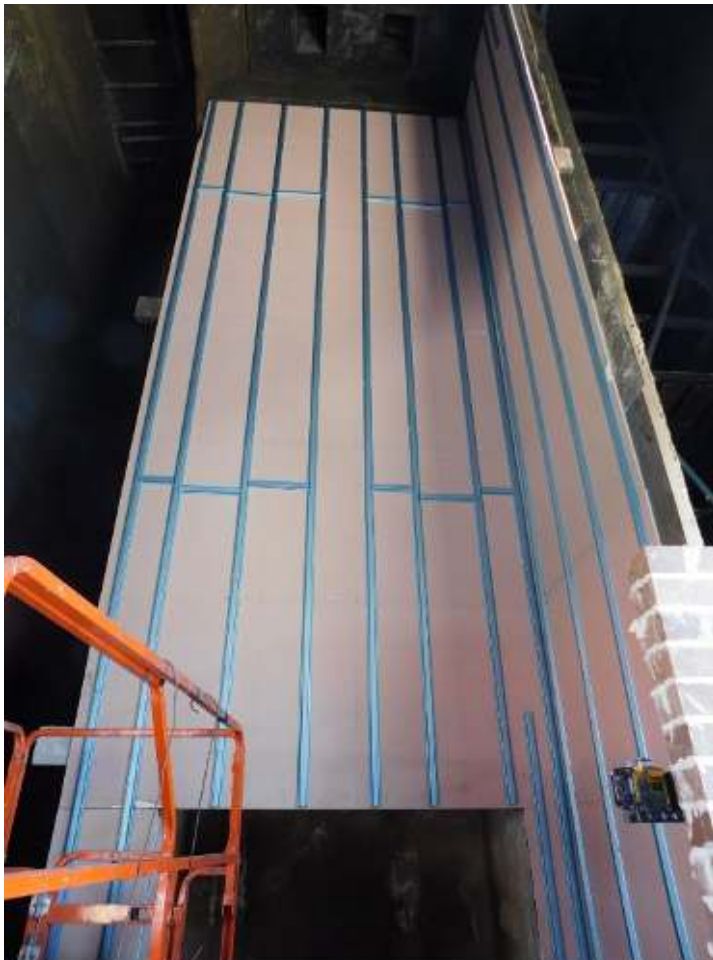
FIGURE 2:

TOP HAT INSTALLATION

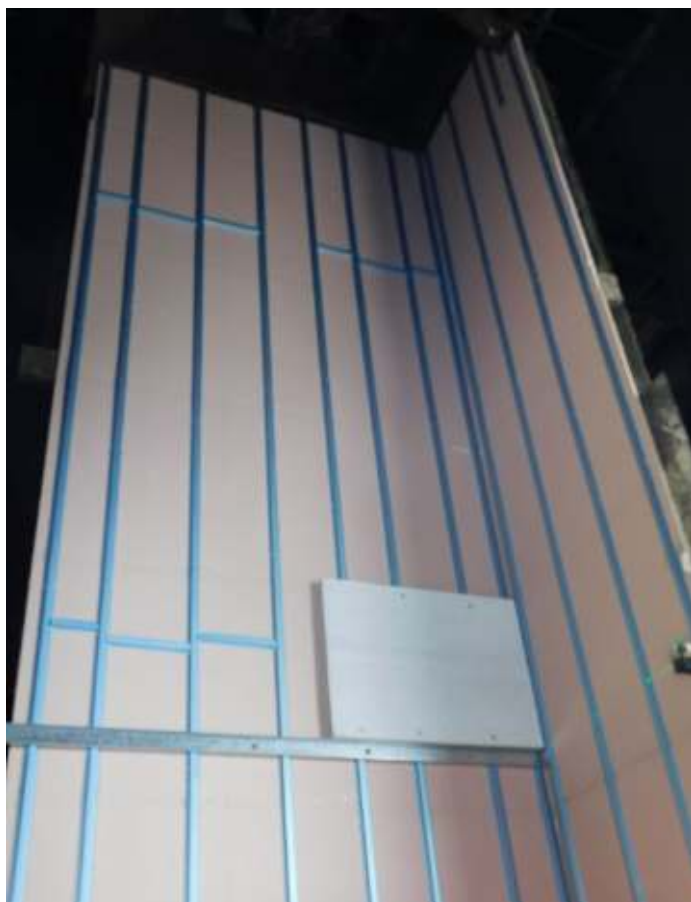
FIGURE 3:

QT SYSTEM INSTALLATION

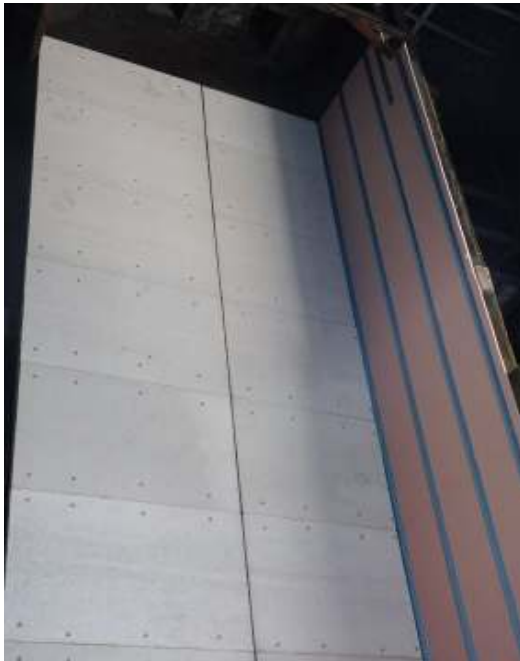
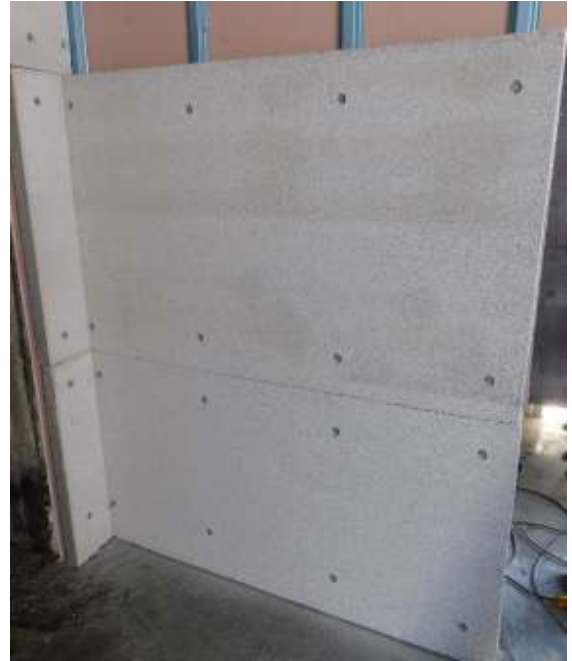
FIGURE 5:
QT SYSTEM INSTALLATION

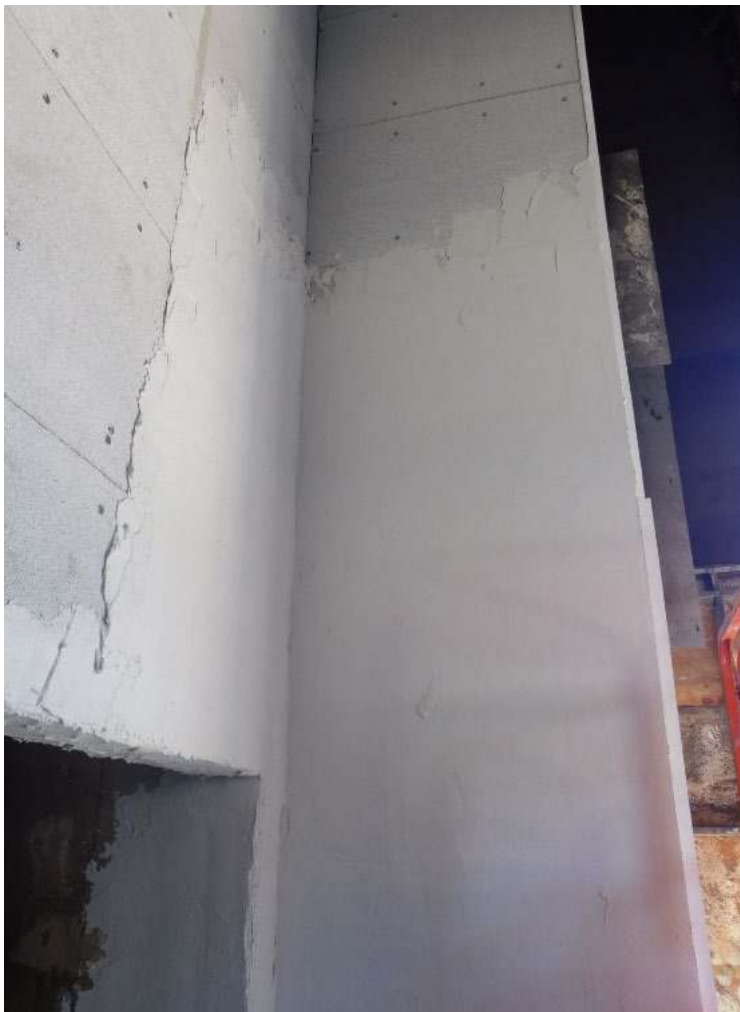
FIGURE 6:
CEMENT RENDER INSTALLATION

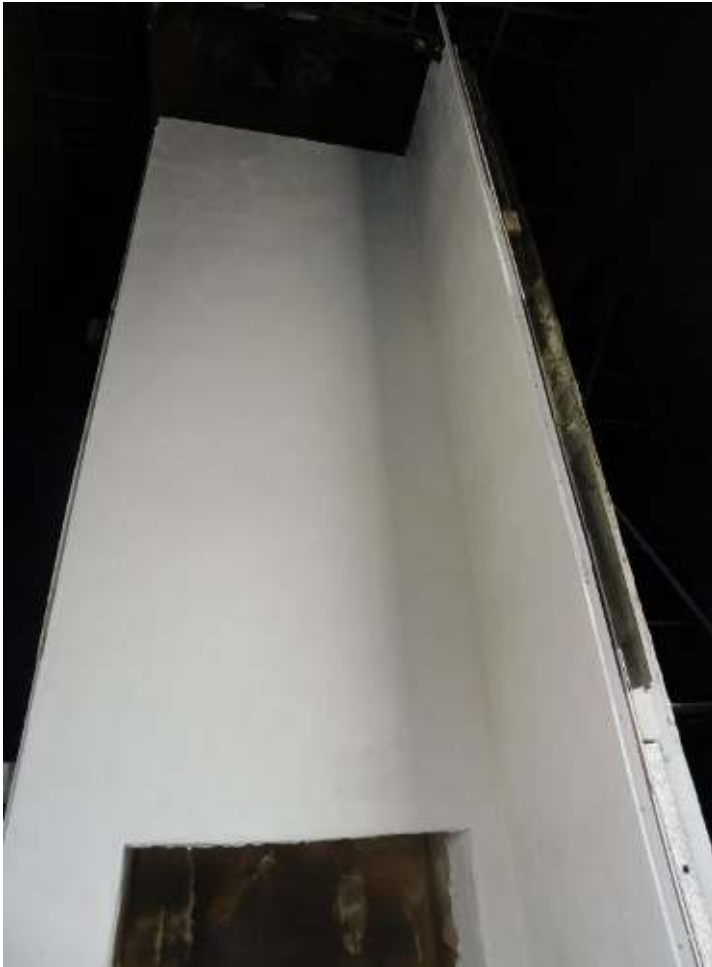
FIGURE 7:

CEMENT RENDER INSTALLATION

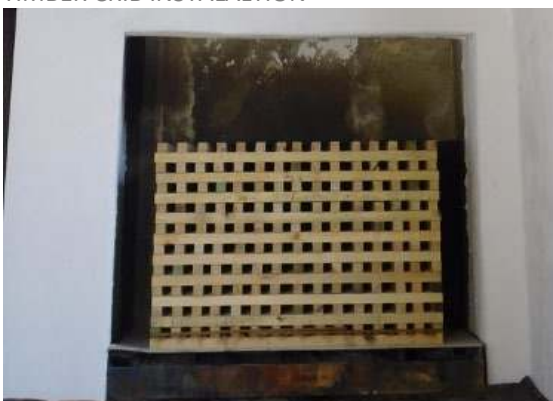
FIGURE 8:

The timber crib included 1500-mm wide, 1000-mm deep and 1000-mm high of pinus radiata being in the order of 50 mm square section. The crib was located centrally within 250mm of each side and within 100mm to the front and rear of the crib platform. Each crib timber element was measured with a J-2000 Delmhorst moisture meter where the moisture content was 10.1%. The following image details the timber crib installation.

TIMBER CRIB INSTALALTION

The crib platform was located on a plinth comprising a single layer of 16mm CSR Fyrecheck and a steel sub-frame to a height of 410mm for the test.

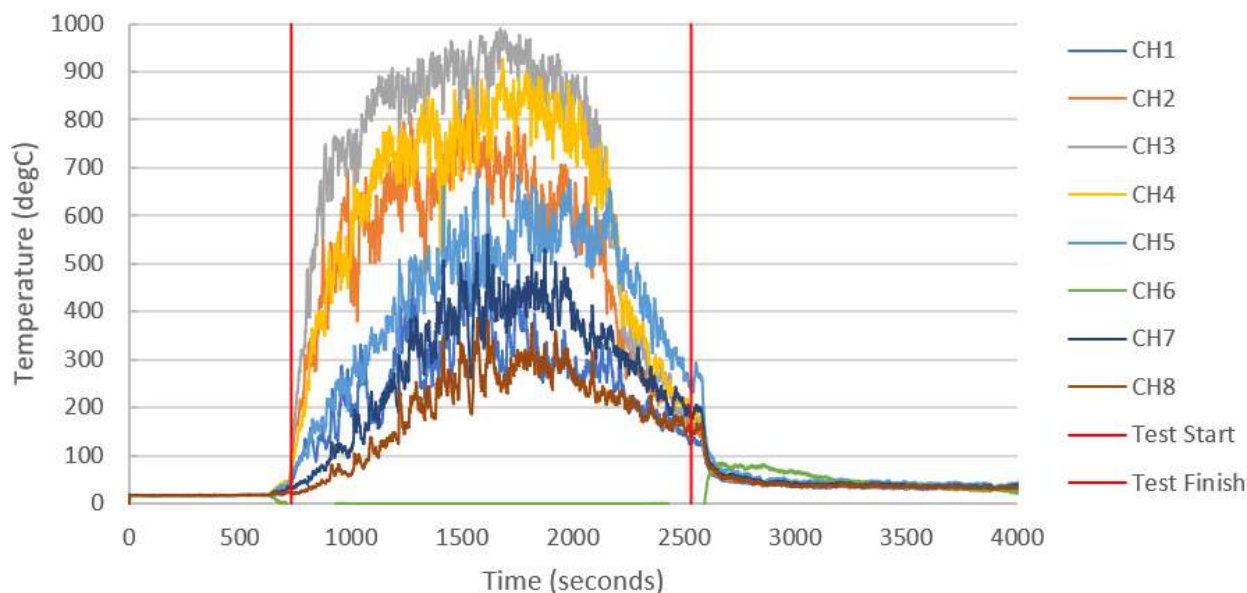
FIGURE 10:

EXTERNAL LEVEL 1 THERMOCOUPLE MEASUREMENTS

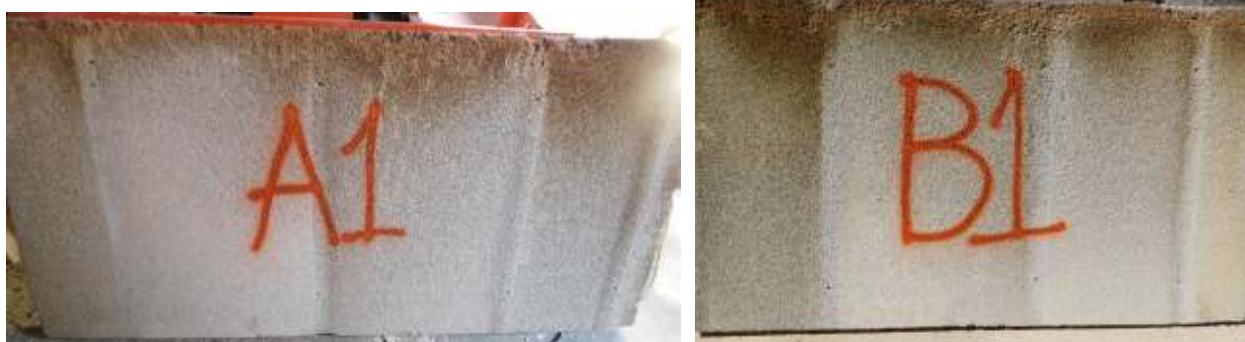
FIGURE 15:

At the conclusion of the test, the top panels of the main wall were removed and the rear of the panels observed. Whilst heat damage was noticed on the edge of the panel, there was no evidence that continuous burning on the back of the panel occurred. The following figure shows the back of the two panels located at the top of the main wall.

BACK OF QT PANEL AT TOP OF SPECIMEN

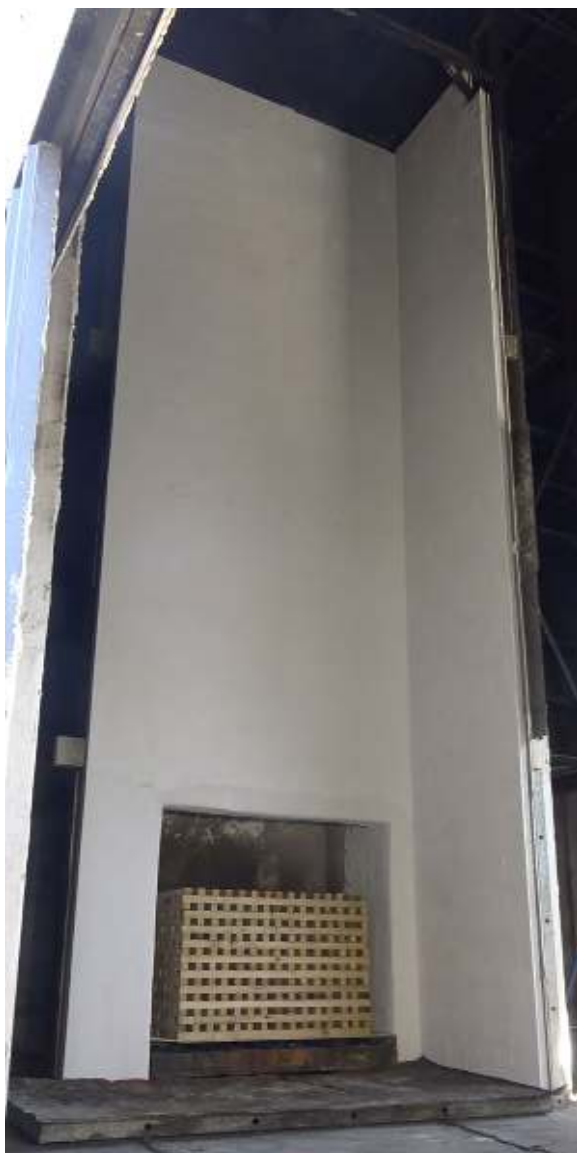
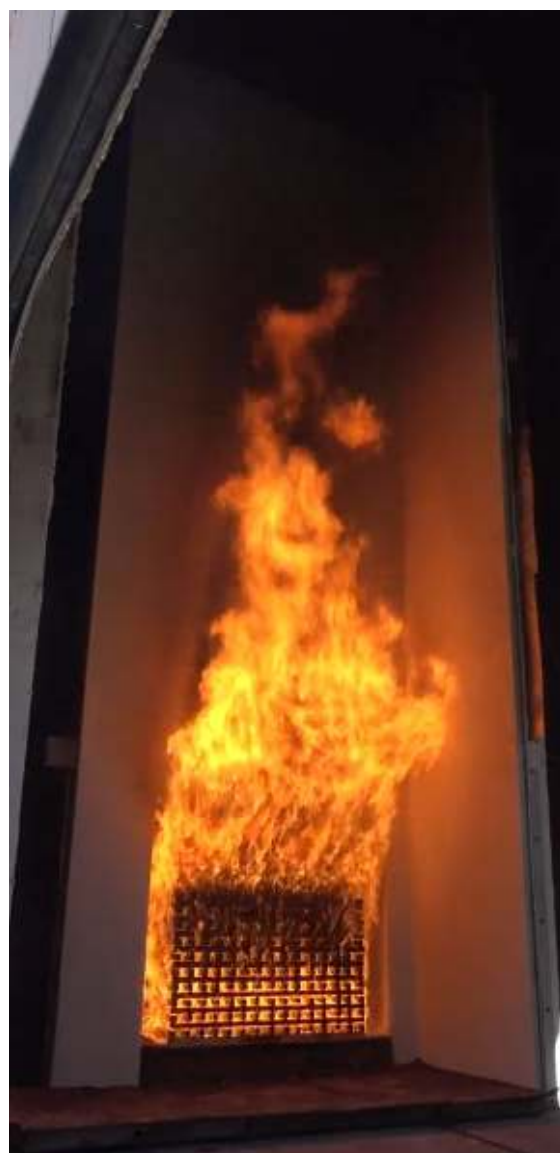
FIGURE 16:

START AND 10 MINUTES

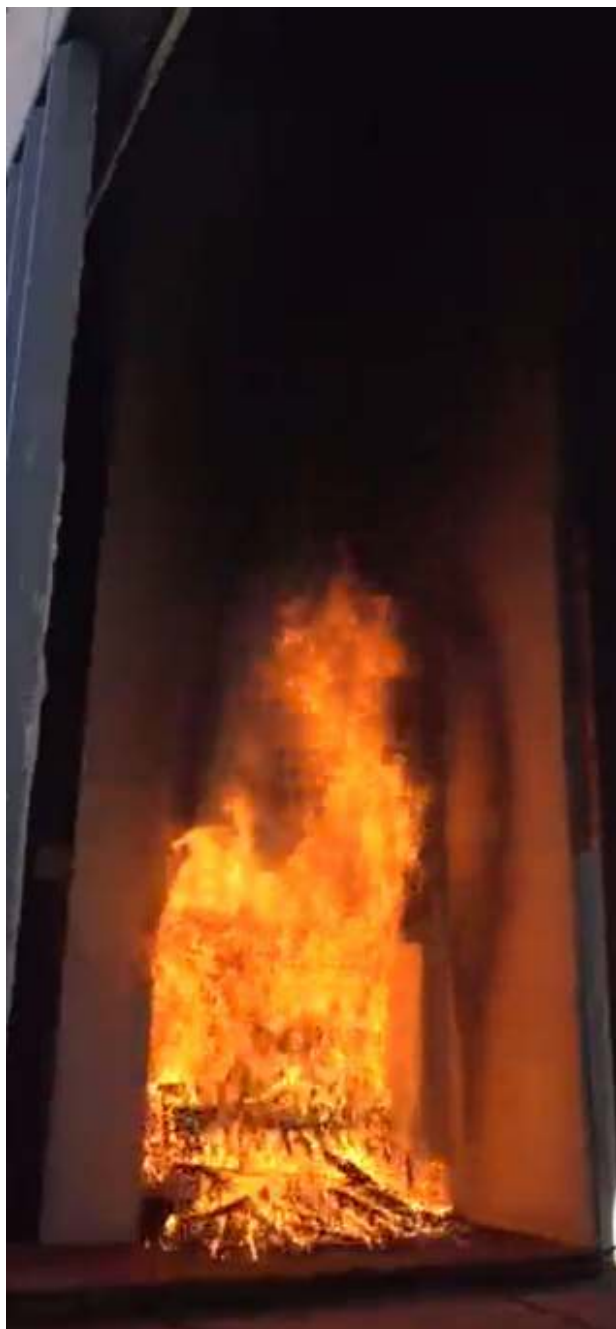
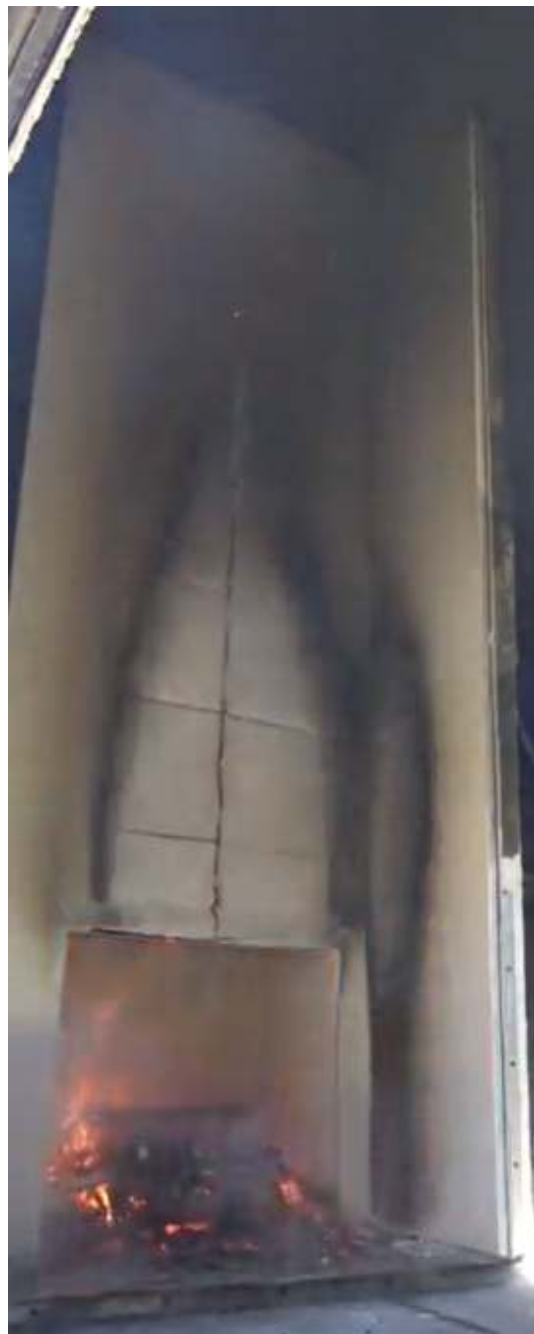
FIGURE 17:

CRIB COLLAPSE AND 30 MINUTES

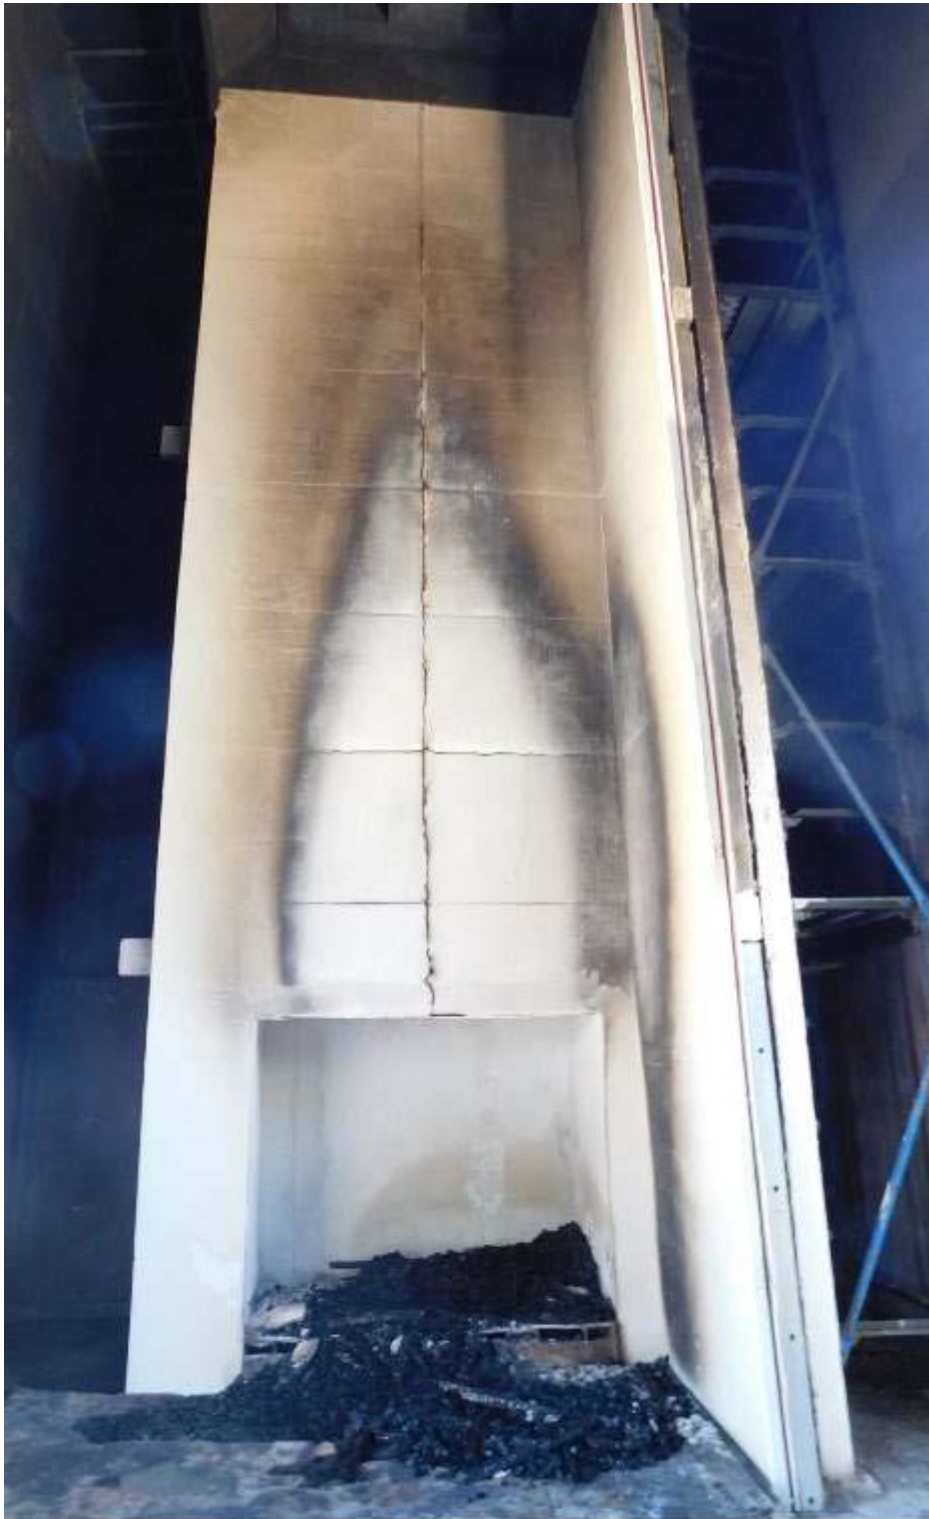
FIGURE 18:

EXTERNAL WALL

From the above image, the QT Conpolcrete panel detailed minor impact along the vertical centreline of the specimen. No observations of fire impact on the plasterboard wall occurred.

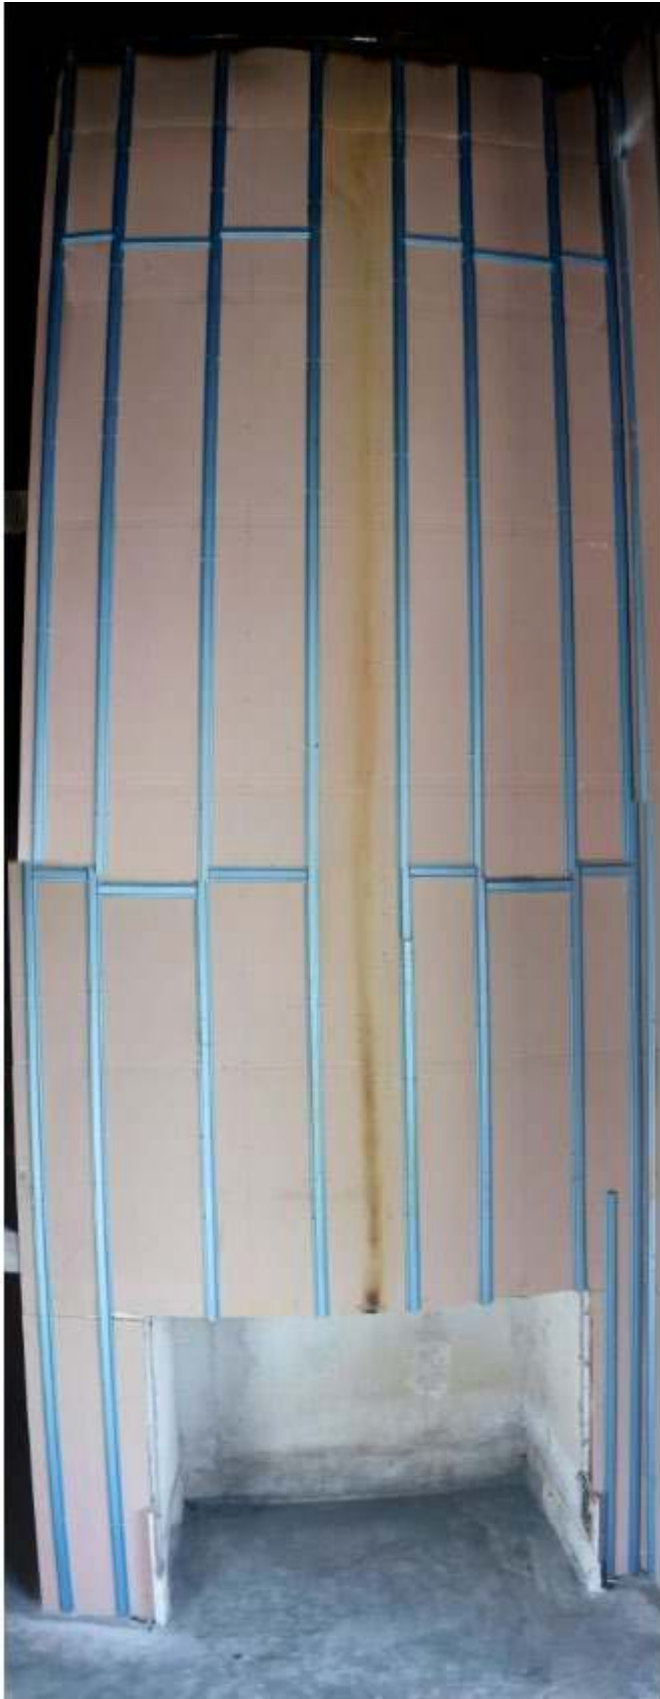
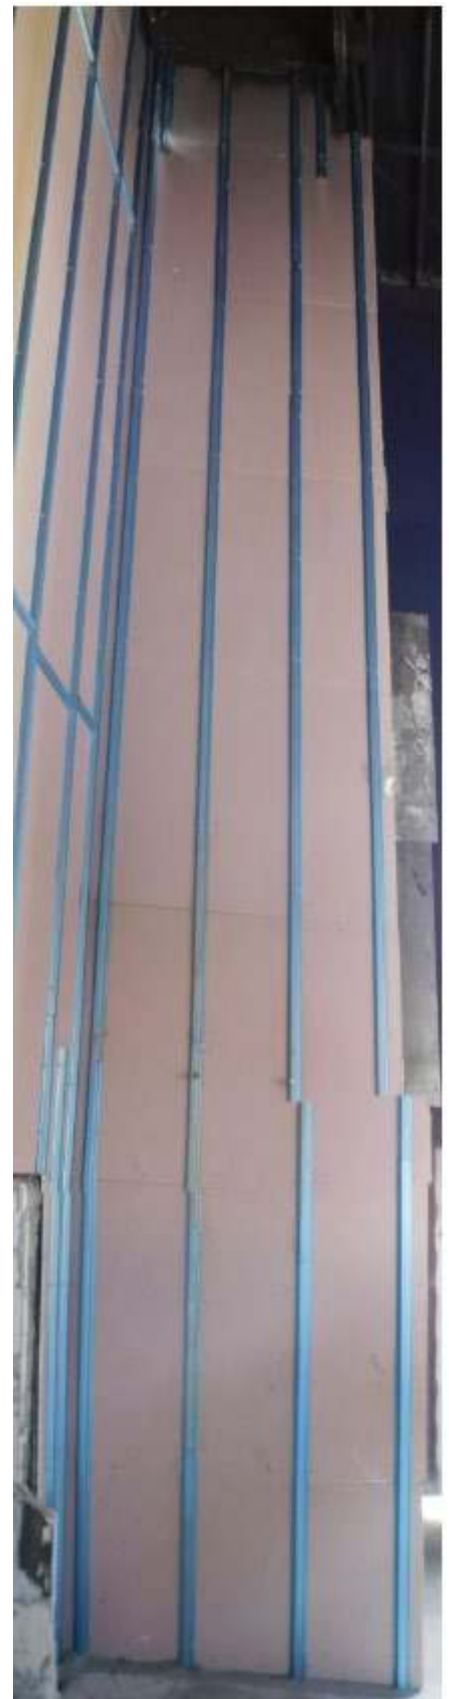
FIGURE 19:
PLASTERBOARD FIRE IMPACT
